Manhole Inspection Summary

Manhole # S39U1_001MH

Insp Date: **5/6/08 1:32 PM**

Location Address: **428 5th St.**

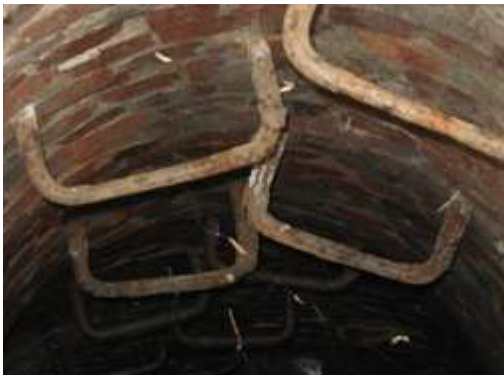
Steps

Count: **9** Missing: **0** ☒ **Corroded**

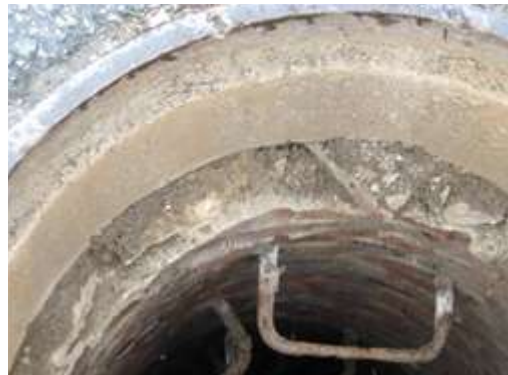
Defect 1

Offset: **2** (in.)

Frame Offset

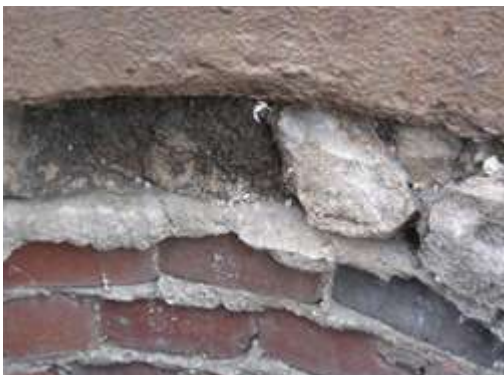
Defect 2

Condition: ☐ Sound ☒ **Cracked** ☐ Root Intrusion ☐ Loose Brick ☐ Deteriorated

Chimney (Cracked)

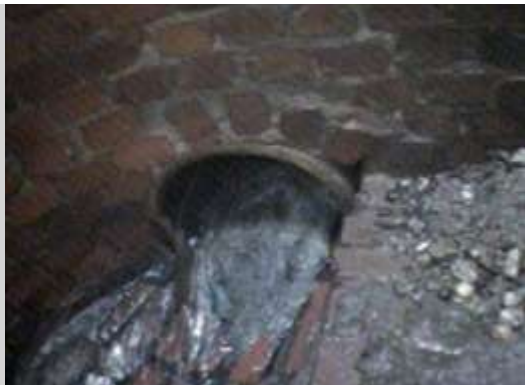
2 O'Clock Inflow

Pipe Height: **12** (in.) Rod and Bar (Angled)
Pipe Material: **Clay** ☐ Pipe Lined
Invert Depth: **14.98** (ft.) Flow Characteristics: **Slow**
Deposits: ☐ None ☐ Mud ☒ Sludge ☒ Debris ☐ Grease
Silt Depth: **4** (in.) Deposits Extent: **Heavy**
Infiltration: **None** Pipe Seal Cond: **Sound**

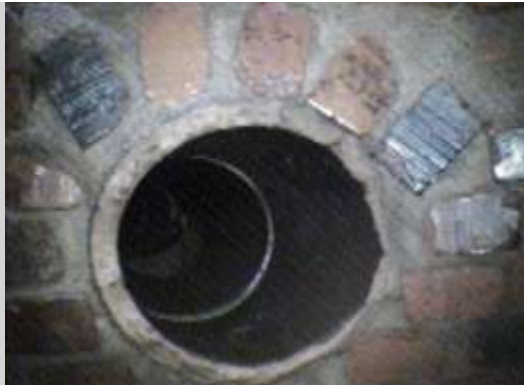
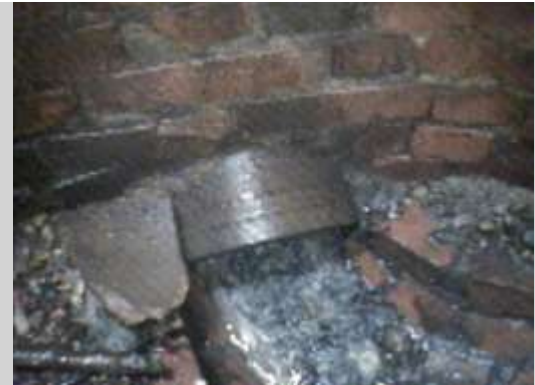
10 O'Clock Inflow

Deposits: ☐ None ☐ Mud ☒ **Sludgy** ☐ Debris ☐ Grease

Silt Depth: **3** (in.) Deposits Extent: **Medium**

Drop Condition: **Partly Clogged**
